# **City of South Bay, Florida**

## **NPDES Stormwater Permitting Program**

**FY 18/19**

**‘Structural Controls’**

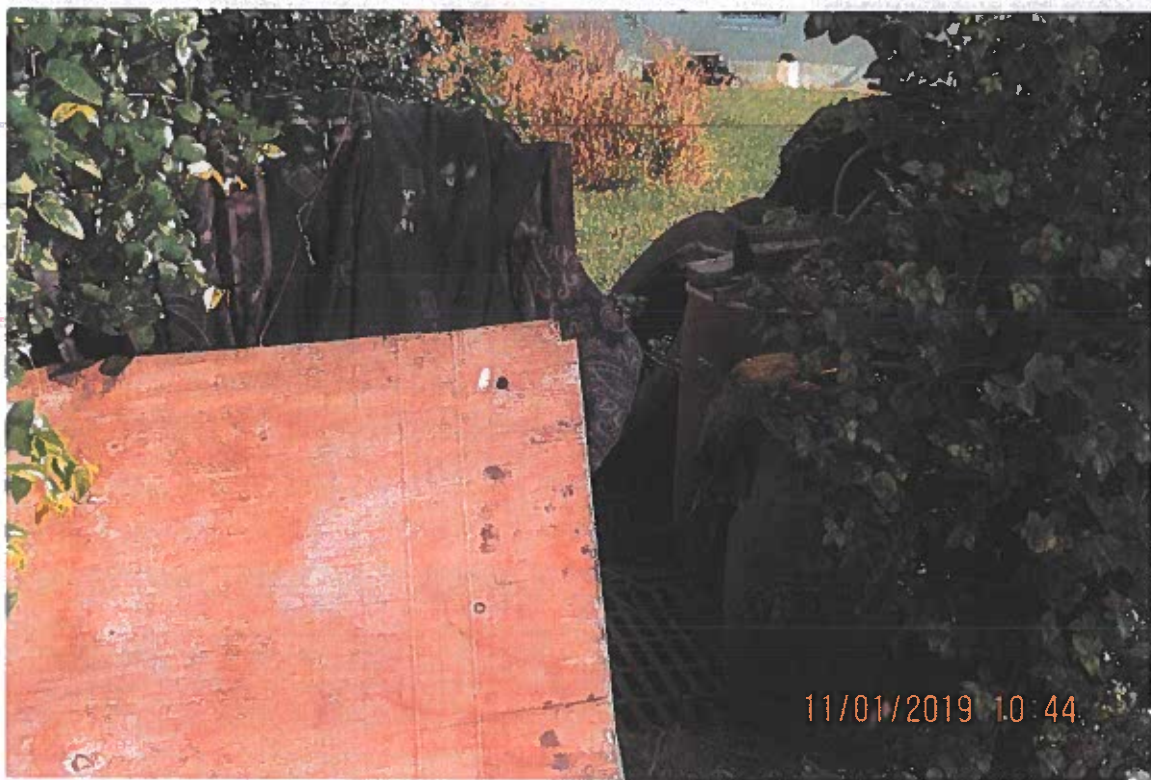
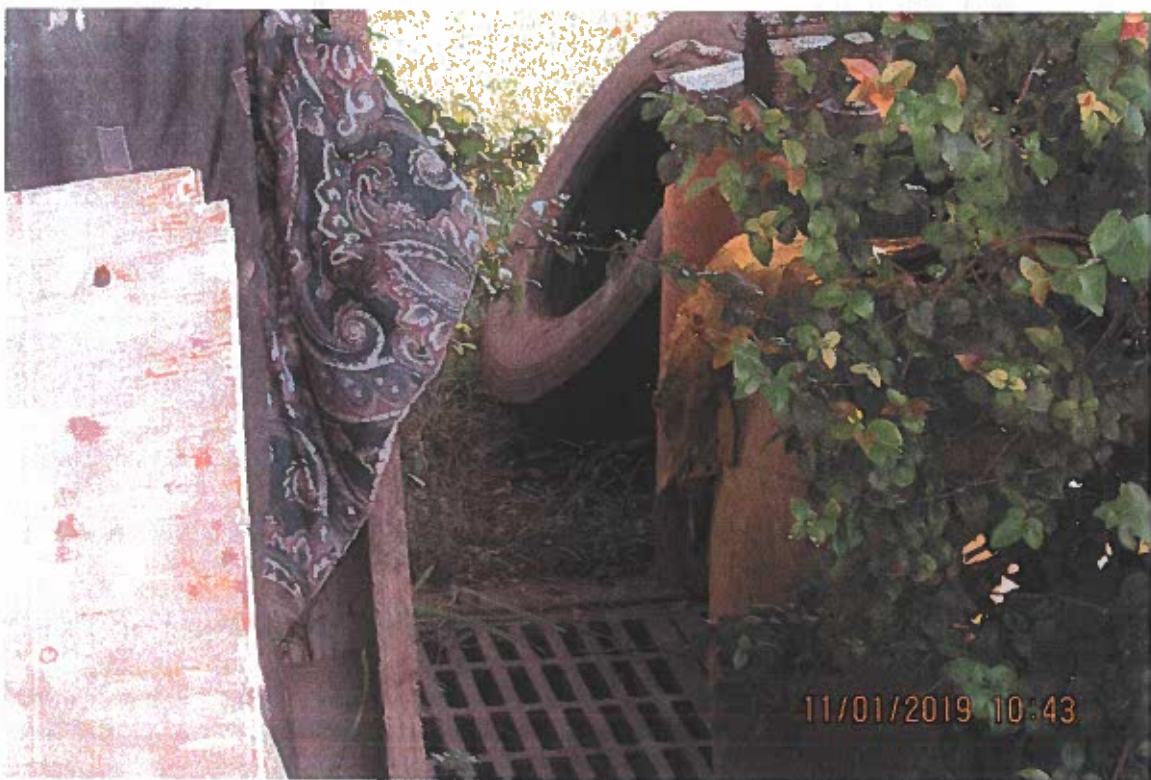
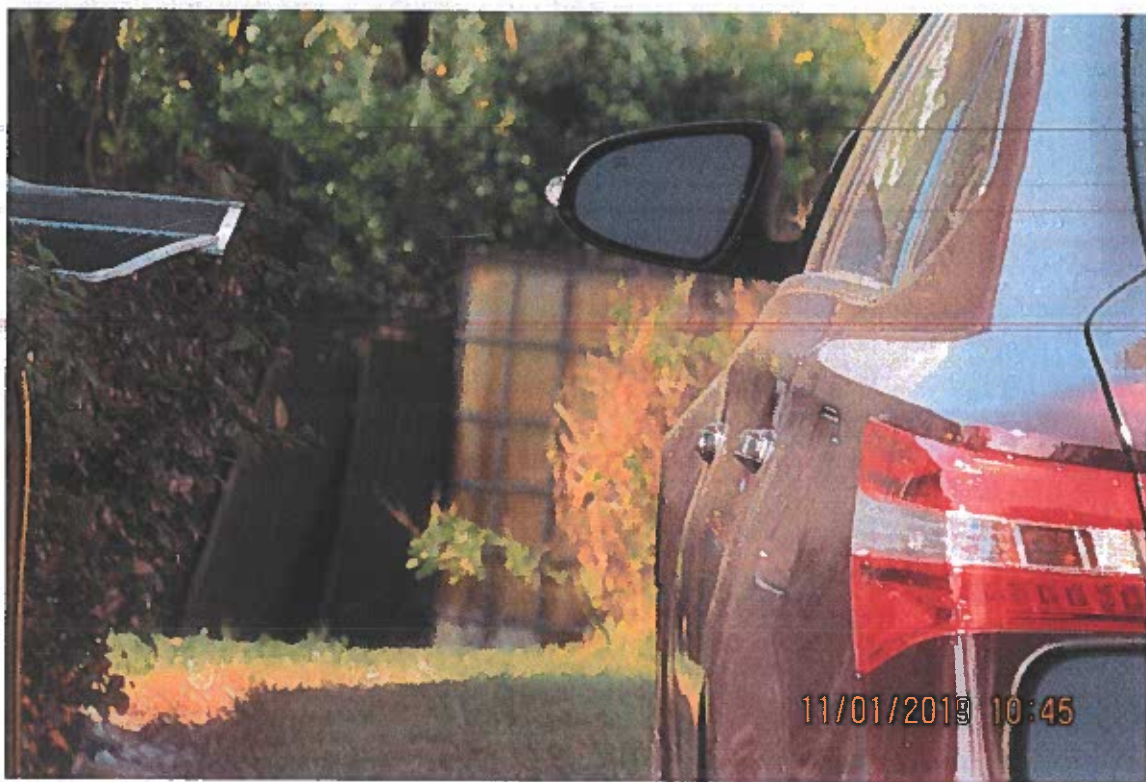
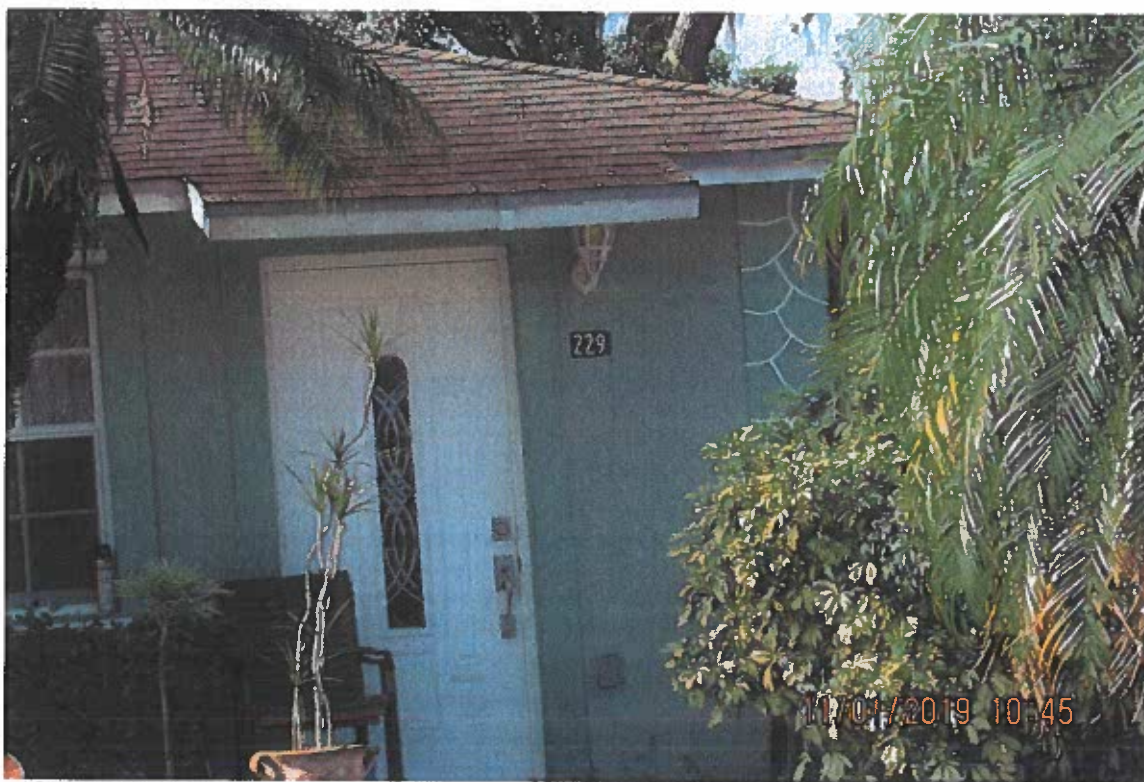
During my routine patrol, I noticed several area(s) of concern.

- Removal of items surrounding the storm sewers and sanitary sewers.
