**NPDES STORMWATER PERMIT STRUCTURAL CONTROLS
INSPECTION FORM: CONTROL STRUCTURES**

Permittee: Town Of Haverhill STR ID: STR1 Type: Sluice Gate

Description: 2-ft operable gate with 6 X 6 in bleeder

Location: Located in the drainage easement at the west end of a trailer park adjacent to Haverhill Baptist Church off of Haverhill Road.

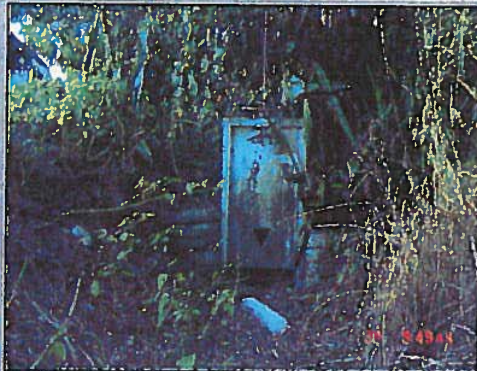
Corrosion: None

Erosion: NONE

Debris: NONE

Corrective Action Taken: DITCH MOWED & CLEANED

10/18/2018

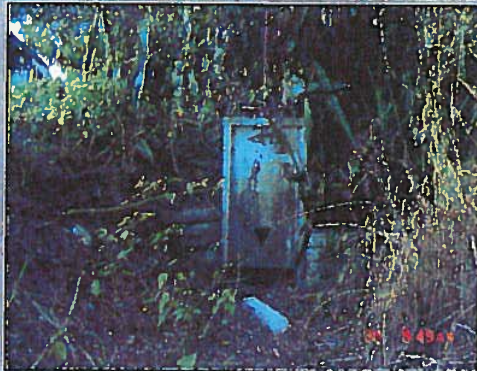
Corrosion: None

Erosion: NONE

Debris: NONE

Corrective Action
Taken:

DITCH FLOWED & CLEANED
11/28/18

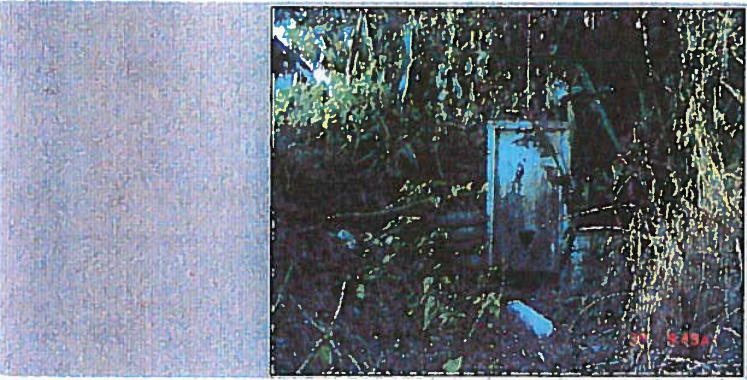
Corrosion: None
Erosion: NONE
Debris: NONE
Sediments: _____
Other: _____
Condition: _____

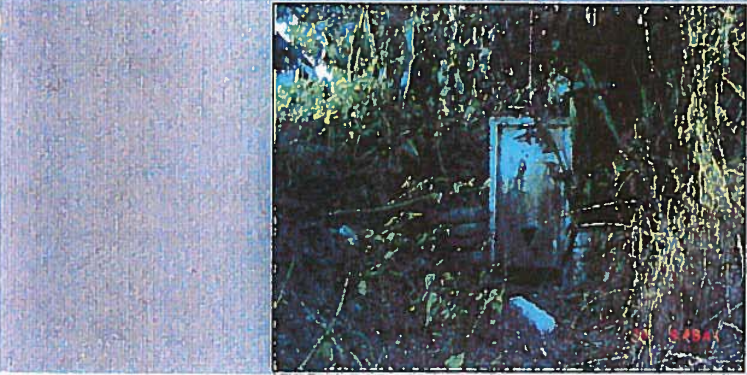
Corrosion: None
Erosion: NONE
Debris: NONE
Sediments: _____
Other: _____
Condition: _____

Comments and Recommendations: _____
Corrective Action Taken: DITCH MOWED & CLEANED 1/15/19

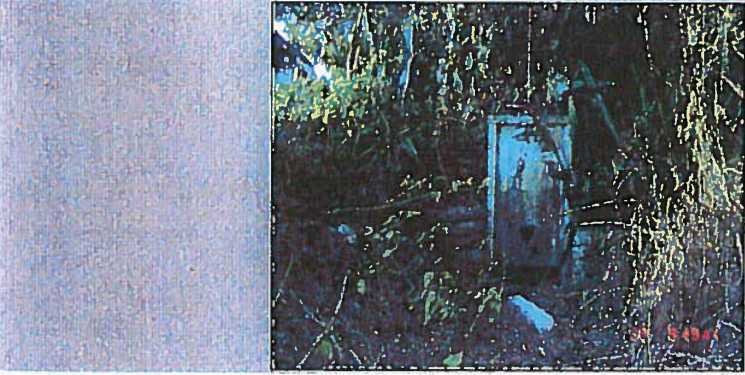
Corrosion: None
Erosion: NONE
Debris: NONE
Sediments: _____
Other: _____
Condition: _____

Comments and Recommendations: _____
Corrective Action Taken: DITCH MOWED & CLEANED
3/4/19

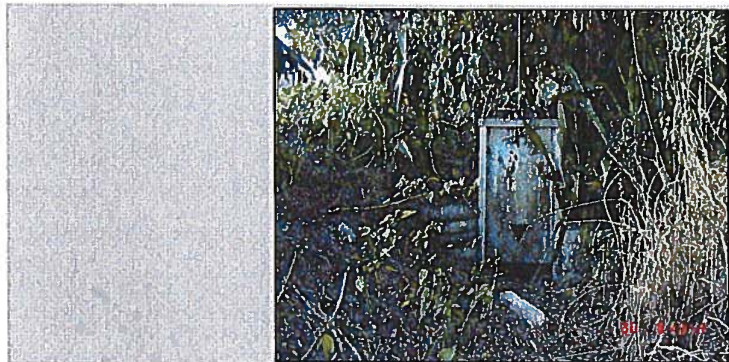
Corrosion: None
Erosion: NONE
Debris: NONE
Sediments: _____
Other: _____
Condition: _____

Comments and Recommendations: _____
Corrective Action Taken: DIKEN MOWE & CLEANED
5/15/19

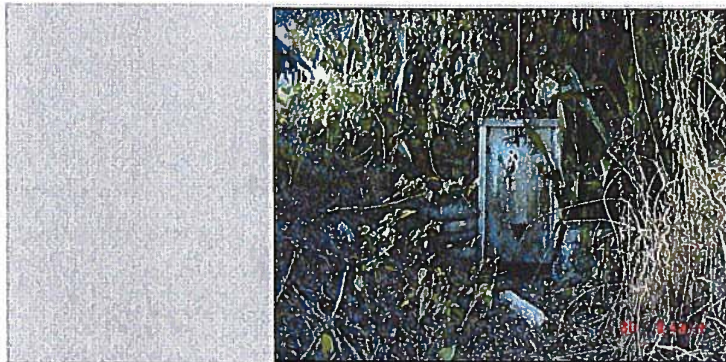
Corrosion: None
Erosion: NONE
Debris: NONE
Sediments: _____
Other: _____
Condition: _____

Comments and Recommendations: _____
Corrective Action Taken: DITCH MOWED 6/27/19

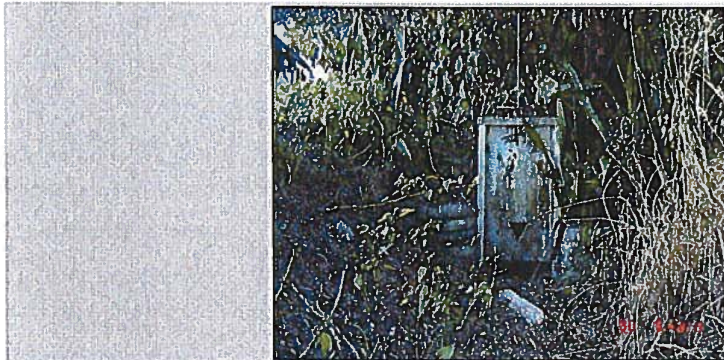
Corrosion: None
Erosion: SOME BEHIND HAVERHILL COURT — CORRECTED
Debris: SOME BEHIND HAVERHILL COURT — REMOVED
Sediments: _____
Other: _____
Condition: _____

Comments and Recommendations: DITCH MOWED & CLEANED 7/22/19
Corrective Action Taken: _____

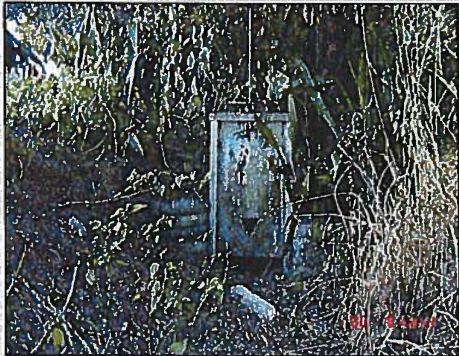
Corrosion: None
Erosion: _____
Debris: _____
Sediments: _____
Other: _____
Condition: _____
